## Introduction

In June of 2024 Stephen Tilly, Architect (STA) was engaged by the Washington's Headquarters Homeowner's Association, represented by Ken Colao (KC), Board Member, and Belinda Watts (BW), Principal of Row Partners (Owner's Rep), to perform probes at the Washington's Headquarters at 152 Broadway in Dobbs Ferry, NY. The probe locations were determined in discussions between Andreas Hubener (AH) of STA, BW, KC, and Dariusz Mikucki of NY Hill.

**PROBE LOCATION #PL1: (Bldg. 3) Unit 7 Front – Probe Locations**

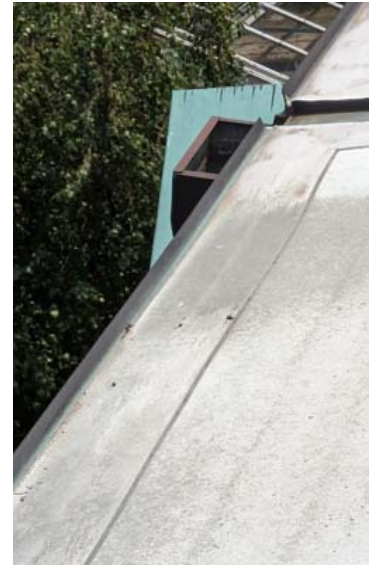
IMG. 7-110

Conditions: -Incorrect top flashing (between flat roofing and shingles on mansard façade) in poor condition (IMG. 7-110)  
-Missing scupper and leader  
-Shingles in poor condition (IMG. 7-112).

Solutions: -Install new gravel-stop type of flashing, tie it to flat roof. Consider all new roofing membrane on flat roof (IMG. 5-120 shows correct installation on Unit 5).  
-New shingles on mansard façade front and back  
-Reinstall scupper/leader to match other units. Dbl. elbow at bottom of leader (IMG. 8-130 shows correct installation at Unit 8).

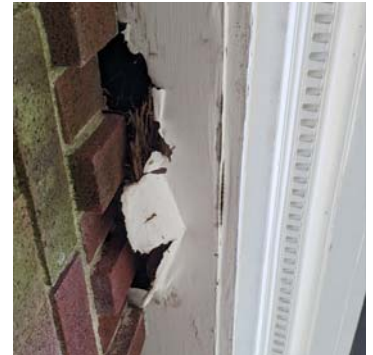
IMG. 7-610

Conditions: -Deteriorated top panels at both dormers (not shown)  
-deteriorated wood sill and apron (IMG. 7-610)  
-Hole on top of cornice flashing (IMG. 7-612)  
-Deteriorated wood underside of cornice (IMG. 7-650).  
Abandoned bird's nest inside cornice (IMG. 7-660).

Solutions: -Repair top panel and drip edge as per detail A at end of report.  
-Repair or replace side panels, sills, aprons, and related side panels and trim as required at both dormers. Dormer framing and base plywood are not impacted  
-Repair end of floor joists, rim joist, and cornice cover boards & trim as required.  
Removal of the entire cornice is NOT required.  
-Solder hole on top of cornice flashing.

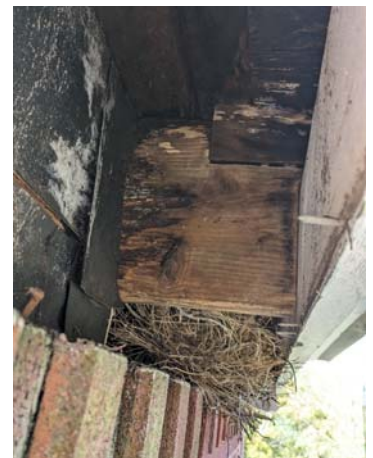
IMG. 7-650 Deteriorated Cornice

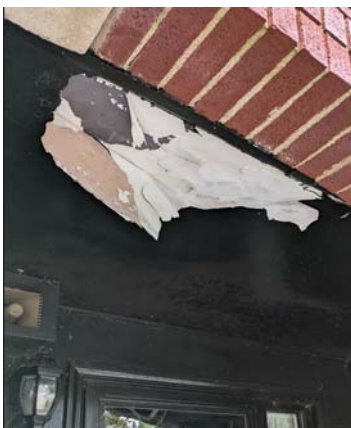
IMG. 7-910

Conditions: -Deteriorated paneling at entrance soffit caused by water infiltration (IMG. 7-910).  
-Soffit framing appears not to be impacted.

Solutions: -Further investigate cause of water infiltration.  
-Replace insulation.  
-Repair and seal soffit.

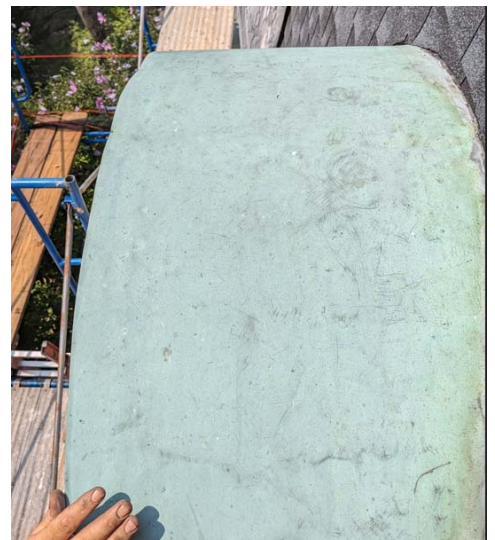
IMG. 5-554

- Although shingles on mansard façade appear to be relatively new, they are of poor quality and/or are poorly installed, resulting in several patches of missing shingles (not shown).
- Improper installation of drip edge. Deteriorated top panels at both dormers (IMG. 5-510 after removal). Base plywood is not impacted.
- Deteriorated side panels at both dormers (IMG. 5-554 & 5-555, during and after removal). Base plywood is slightly impacted.
- Correct installation of copper top of barrel (IMG. 5-210). Gap between copper top and wood trim (IMG. 5-250). Comparable details at Bldg. 5 (Unit 15) are constructed differently.

- New mansard roofing only in back.
- Replace top panels and trim (seal gap). Repair includes drip edge as per Detail A at end of report.
- Replace side panels, sills, aprons, and related trim as required at both dormers. No repairs at dormer framing and base plywood required.

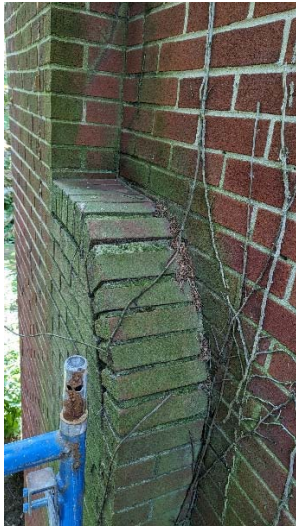
Conditions  
Brick: -The wash brick at the shoulder of the chimney was loose because of deteriorated mortar (IMG. 9-710). Removal of the horizontal and curved sections of brick showed that bricks and mortar below are in good condition (IMG. 9-720). Note biological growth. Similar deterioration of varied severity appears at (8) locations throughout the compound: (4) quarter-round as shown here, (4) as straight diagonal lines of brick as shown in IMG. 8-810 at Unit 8.

Solutions:  
-Clean brick at chimney; remove all loose bricks and mortar; install salvaged or specified new brick; repoint as required.  
-Cut deeper groove and install new copper flashing with ¾” reglet at oriel, caulk.  
-Further investigate water infiltration by opening ceiling inside and removing brick at end of lintels outside.  
-Install new lintel if required. Repair brick.  
-Re-solder/repair oriel roof.  
-Adjust oriel or window to ensure proper window operation. Replace windows if required.

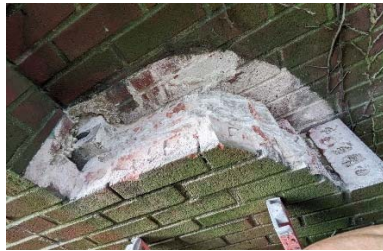
Conditions  
Oriel: -Water damage at the ceiling of the oriel (IMG. 9-810).  
-The top flashing (removed in IMG. 9-852) appears not to be the entry point for water. The reglet of the flashing is very shallow though – less than ½”.  
-Mortar on both sides of the oriel eave fell off and exposed a rusted steel lintel.  
-The entire oriel appears to be askew. The outside may have sagged, preventing the windows from closing (not shown).  
-Inadequate soldering at several locations of copper oriel roof (not shown).

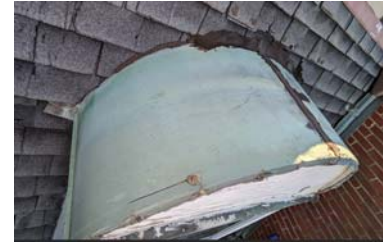
IMG. 15f-510

- Copper barrel dormer roof has been nailed from above. The failed soldering has been sealed with mastic. Improper front edge (IMG. 15f-510).

-Repair or replace copper top of barrel on dormers and install properly (as in Bldg. 3, IMG. 5-210). Repair barrel plywood.

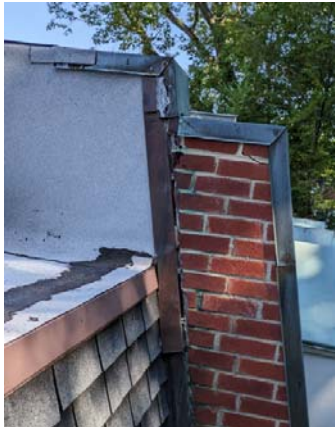
IMG. 15b-150

- Improper installation and repairs of cap flashing on knee wall between Units 14 & 15 (IMG. 15b-150).
- Open seam at cornice flashing (IMG. 15b-310).
- Top of copper barrel flashing has been cut during a previous repair attempt. Note soldering to cover nail heads. Improper front edge (IMG. 15b-505).
- Deteriorated side panels (not shown) and top panels (IMG. 15b-515, after removal) at both dormers. Base plywood is not impacted.
- Improper pitch of drip edge. Caulking between top panel & drip edge (IMG. 15b-520 & IMG. 15b-522), resulting in trapped water at transition.
- Steel grates at patio doors (N.I.C.) are in good condition and do NOT need to be painted (IMG.15b-910).

- Replace cap flashing on knee wall between Units 14 & 15 (roof repair). Consider all new roofing membrane on flat roof and knee walls.
- Replace copper top of barrel at right dormer (left dormer t.b.d.) and install properly (as in Bldg. 3, Unit 5, IMG. 5-210).
- Replace top panels and trim (seal only upper gap). Repairs including drip edge as per Detail A at end of report.
- Replace side panels, sills, aprons, and related trim as required at both dormers. No repairs at dormer framing and base plywood required.

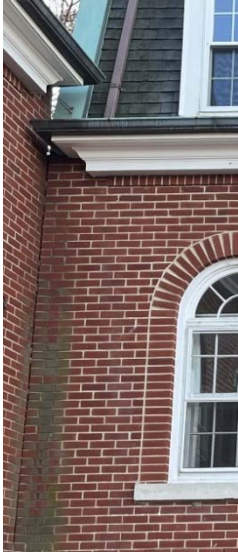
- Biological growth on brick in corner between Units 18 & 19 (IMG. 9-010)
- Transition between units not sealed (IMG. 9-710)
- Roof shingles in poor condition (not shown)
- Deteriorated wood sill and apron (IMG. 9-305)
- Clogged leader. Leader extends too close to cornice (IMG. 9-310).
- Return of gutter is back pitched, causing clogging, spilling and biological growth (IMG. 9-312).
- More spilling may be contributed by the gutter of Unit 18 (IMG. 9-302)
- Arched windows in need of putty repairs and painting (IMG. 9-810).

- Clean biological growth.
- Insert backer rod and caulk transition between units.
- Replace top panels, sills, aprons, and related side panels and trim as required at all dormers. Dormer framing and base plywood are not impacted.
- Replace shingles on mansard façades in front and back.
- Shorten 3 of 4 leader and install dbl. elbows at bottom of leader. IMG. 9-305 shows that dbl. elbows are installed at one leader. Consider replacing and properly attaching all (4) leaders during façade shingle replacement.
- Pitch / repair as required / re-attach gutters at both Units 18 & 19.
- Re-putty and paint (3) arched windows (N.I.C.). This requires the removal and possibly replacement of triple-track storm windows.

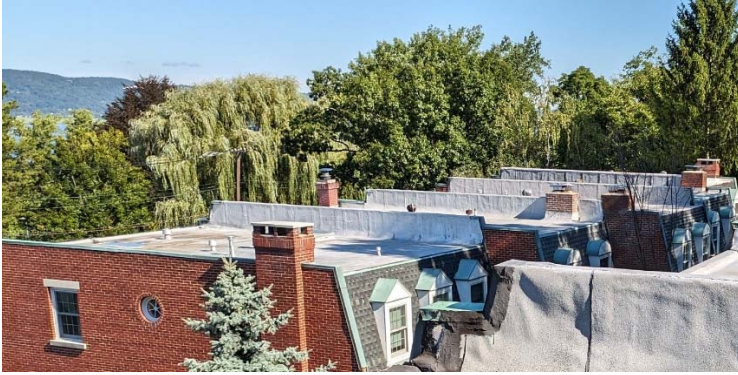
*IMG. 13-010 Flat Roof Membranes in Different Conditions Bldg. 4 (Unit 13&10 Replacement Recommended)*

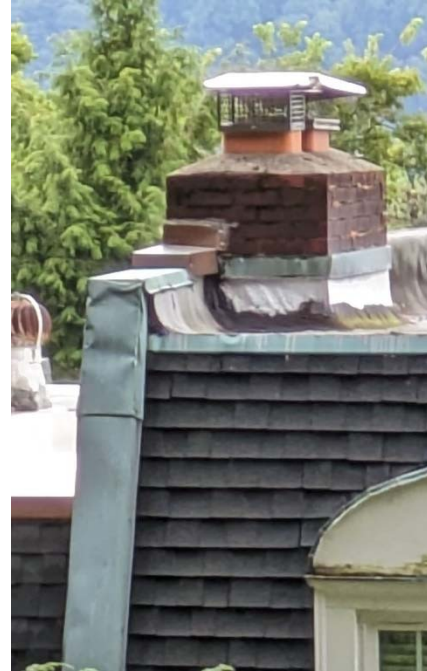
*IMG. 16-010 Flat Roof Membranes in Different Conditions Bldg. 5 (Unit 17 Replacement Recommended)*

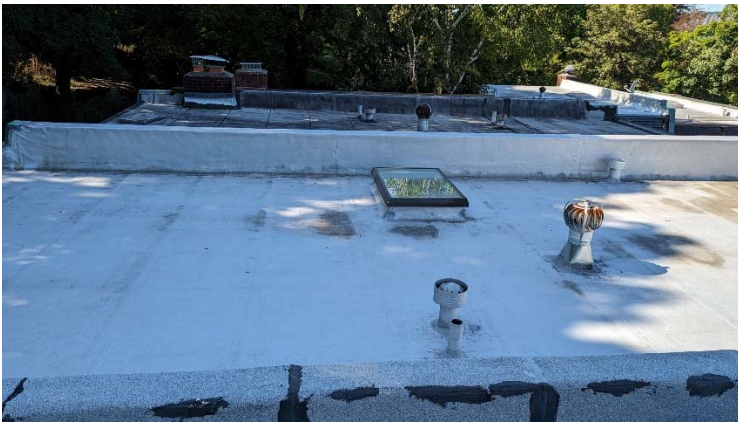
*IMG. 15-110 Poorly Installed Cap Flashing; Expired Flat Roof Membrane Unit 15 Front*

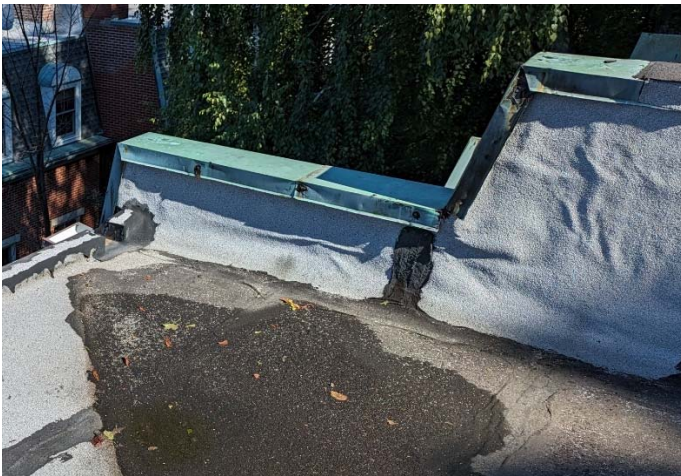
*IMG. 17-150 Chimney to be Cleaned; Poor Flashing & Flat Roof Membrane Unit 17*

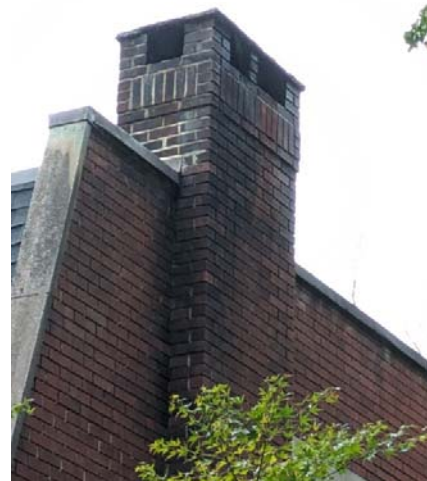
*IMG. 4-150 Chimney to be Cleaned & Repointed Unit 4*

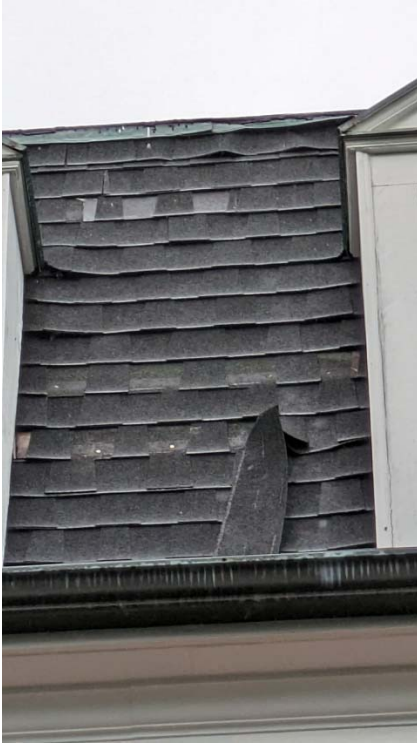
IMG. 13-410 Failing Mansard Shingles Unit 13 Back

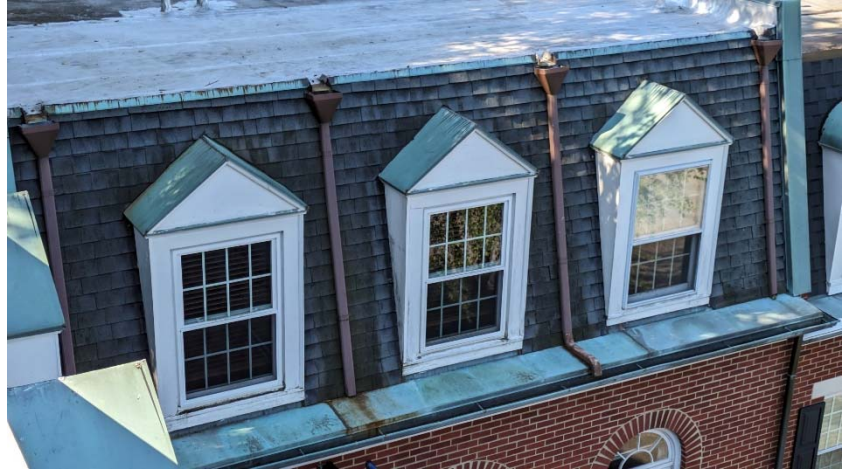
IMG. 19-550 Deteriorated Side Panel, Expired  
Mansard Shingles Unit 19 Front

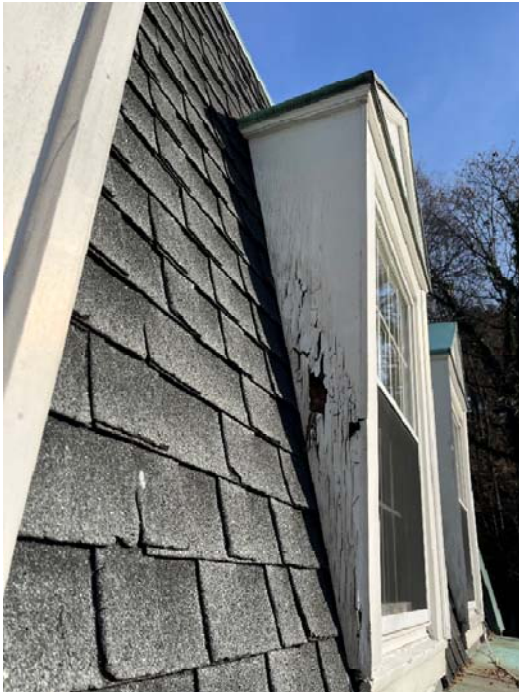
IMG. 19-400 Expired Mansard Shingles; Spilling & Incorrectly Installed Leaders Unit 19 Front

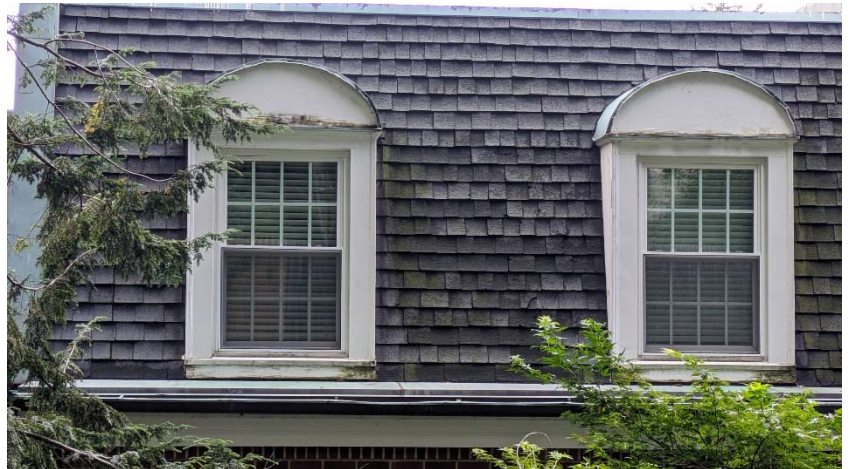
IMG. 17-410 Failing Mansard Shingles; Deteriorated Dormer Panels/Sills/Aprons Unit 17 Back

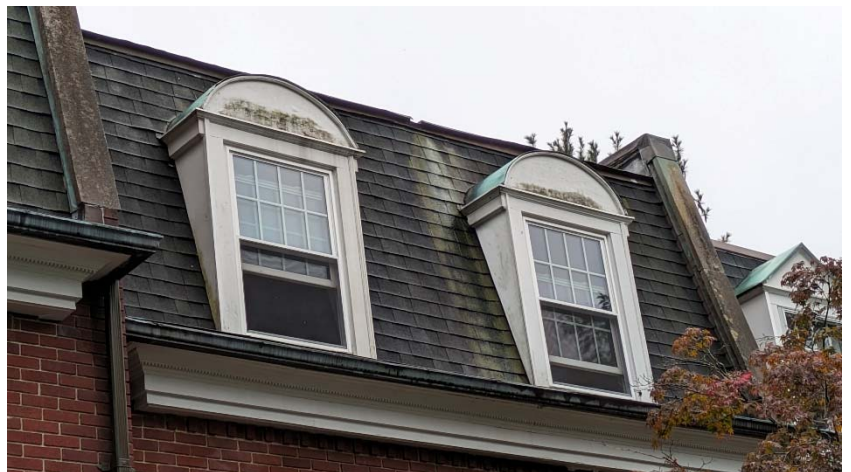
IMG. 7-410 Failing Mansard Shingles; Deteriorated Dormer Panels: Missing Scupper/Leader  
Unit 7 Front

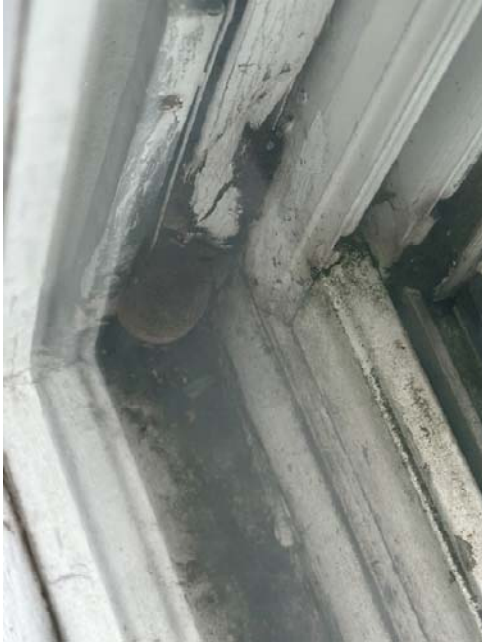
*IMG. 8-810 Deterioration / Growth Between Window & Trim Unit 8*

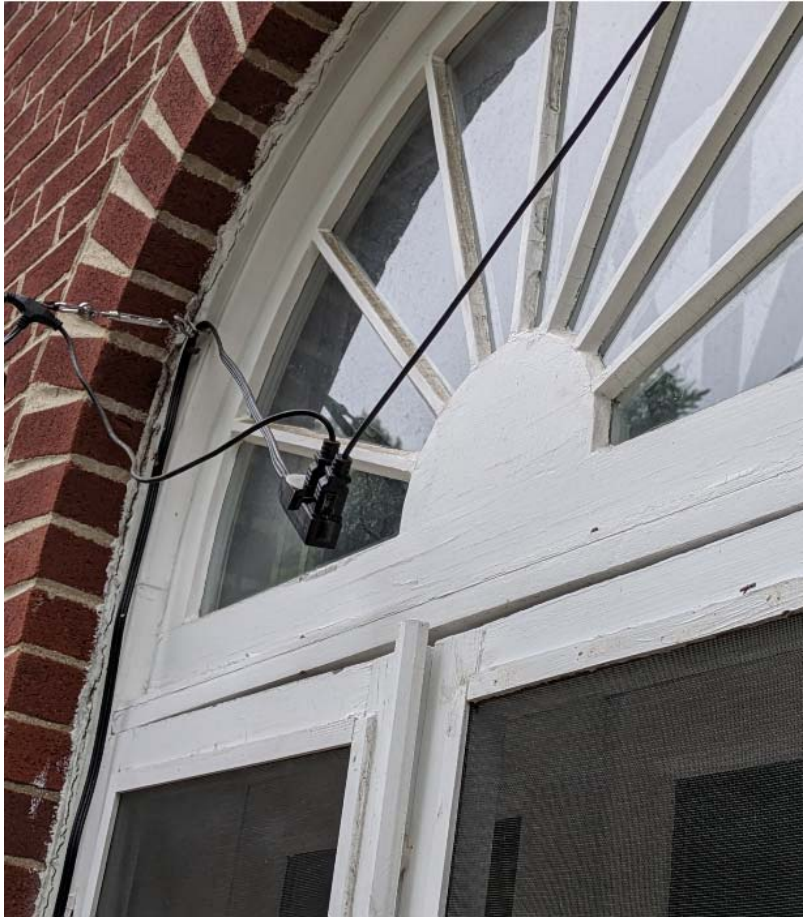
*IMG. 19-550 Deteriorated Window Trim/Sill; Improper Caulk Repairs Unit 13*

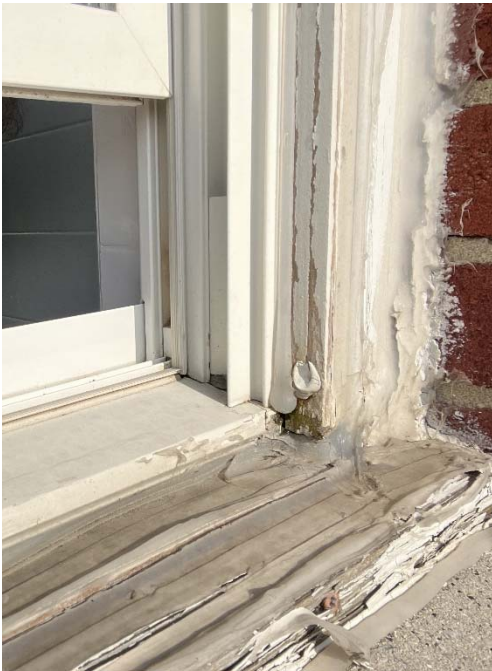
*IMG. 13-810 Failing Caulk (Typ. for All Windows); Window and Storm Door in Need of Paint (Typ. for Most Original Wood Windows) at Unit 13. Repaired since by Owner*

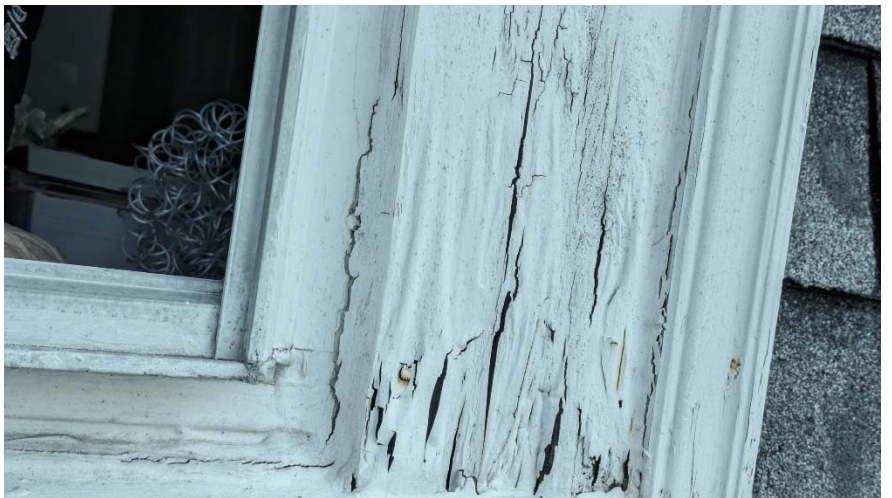
*IMG. 15-810 Deteriorated Trim/Failing Caulk at Dormer Window Unit 15*

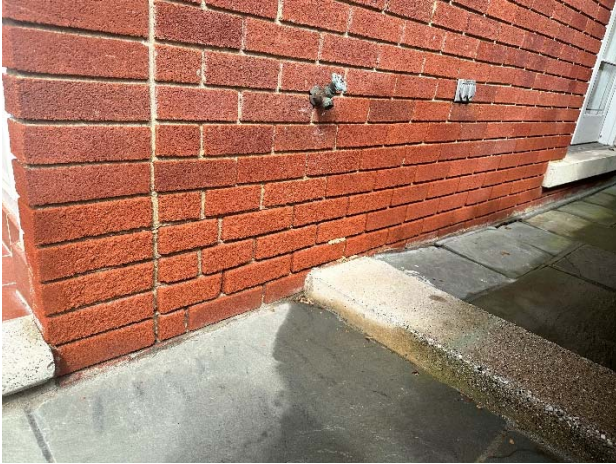
*IMG. 1-710 Deteriorated Brick and Mortar Caused by Backsplash Unit 1*

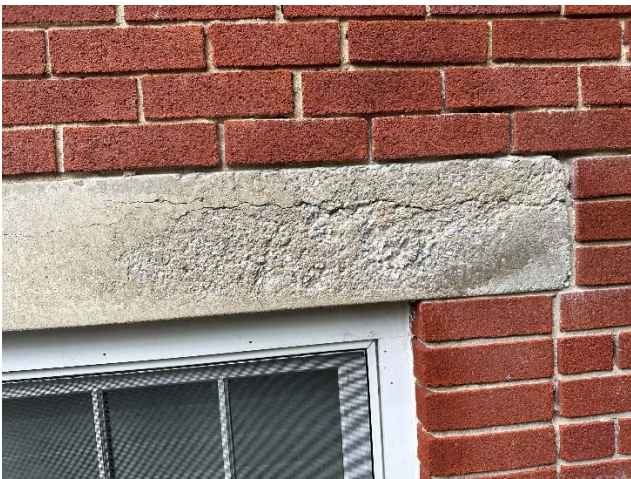
*IMG. 7-750 Deteriorated Cast Stone Lintel Unit 2*

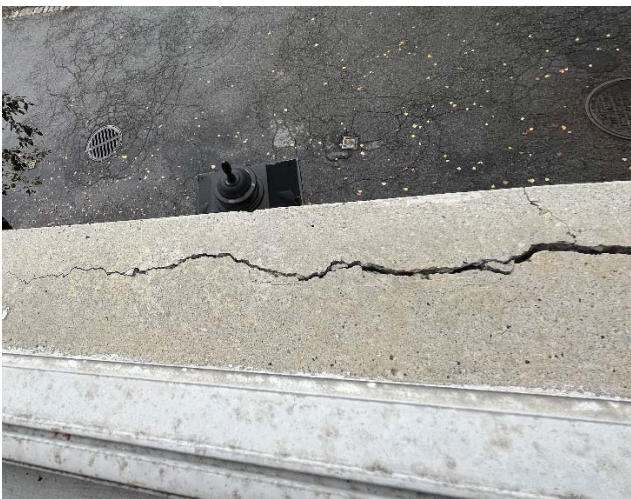
*IMG. 7-750 Cracked Cast Stone Sill Unit 9*

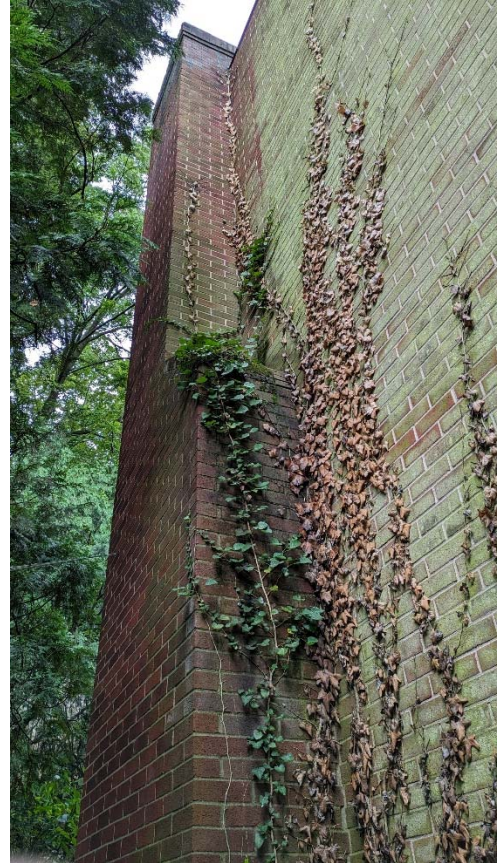
*IMG. 14-720 Biological Growth and Vines Unit 14*

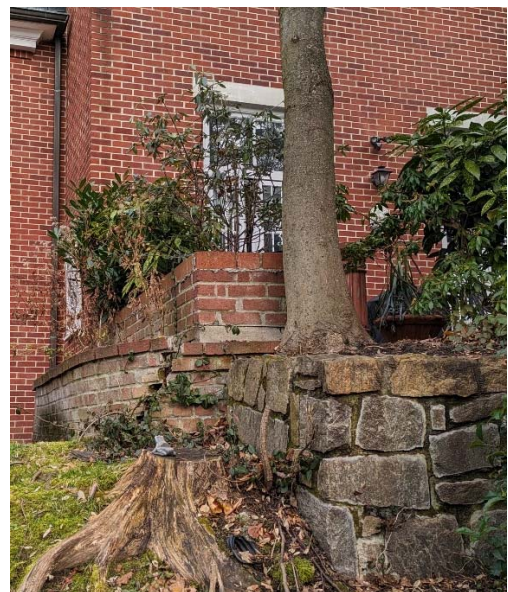
*IMG. 21-910 Crumbling Garden Walls Unit 21 (N.I.C.)*

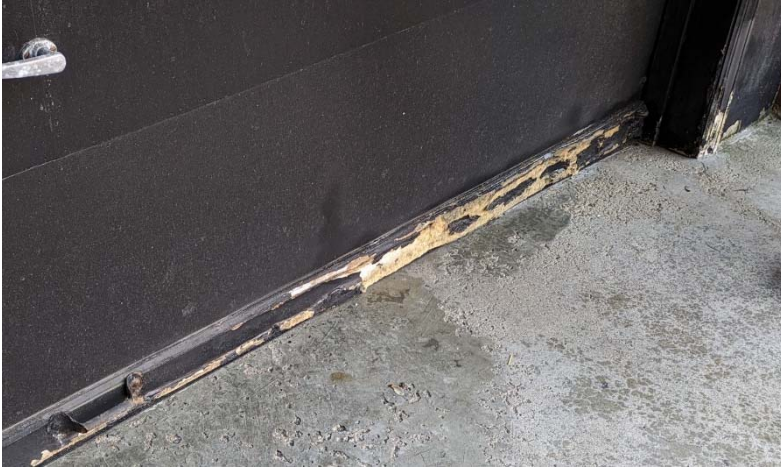
*IMG. 19-640 Deteriorated Bottom Rail Garage Door Unit 19*

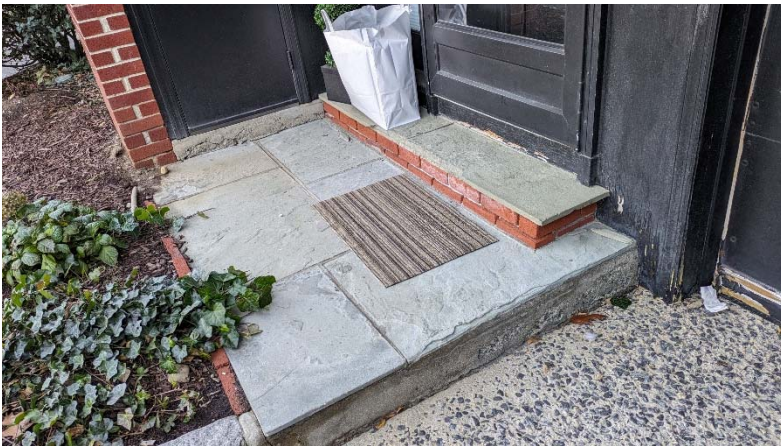
*IMG. 17-960 Spalling Pavers/Washed-Out Mortar Joints at Stoop Unit 17*

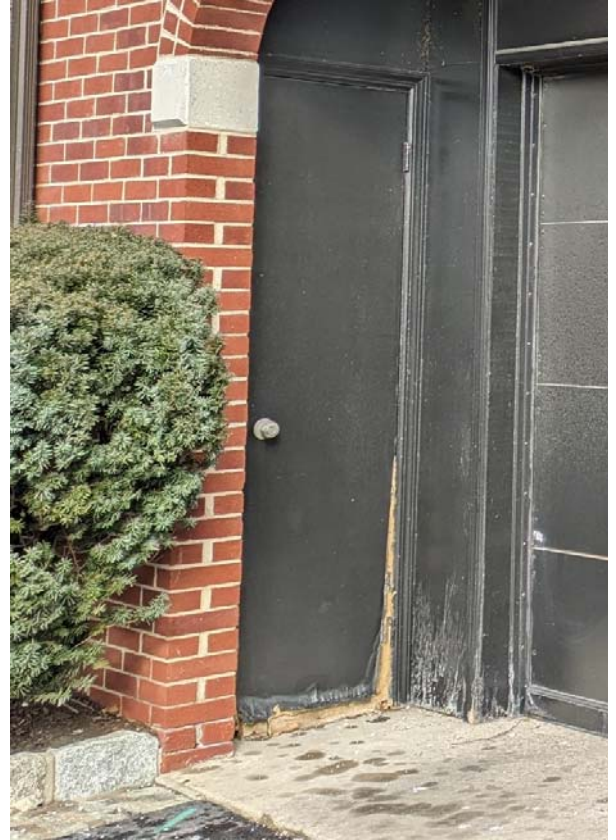
*IMG. 14-650 Deteriorated Utility Door Unit 14*

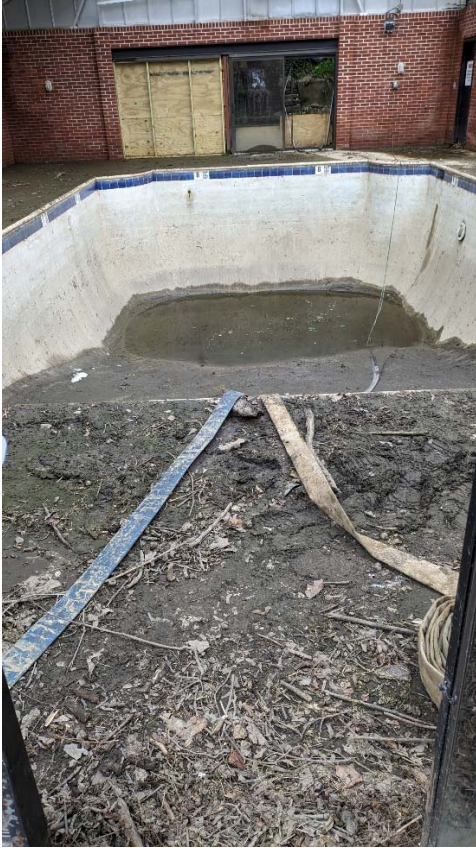
IMG. P-900 Flooded Pool

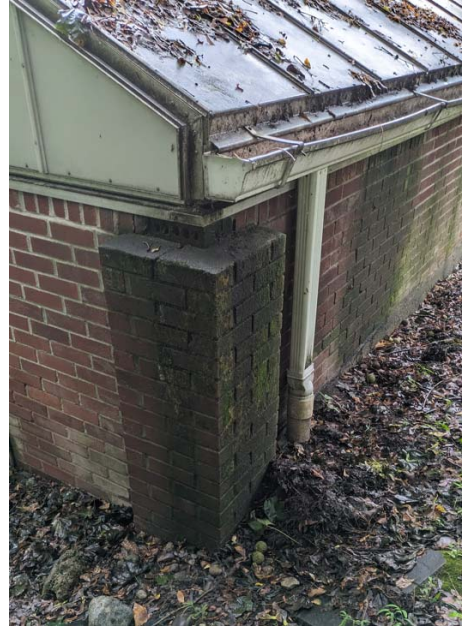
IMG. P-710 Biological Growth & Wash-Out Mortar South Elevation

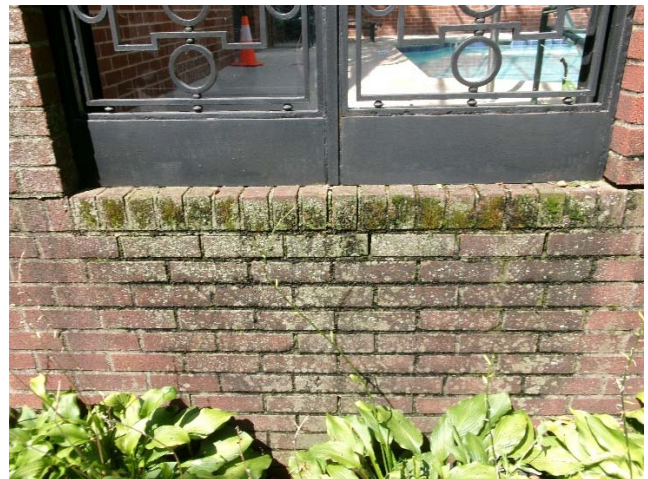
IMG. P-730 Biological Growth & Wash-Out Mortar NW Corner
