## Introduction

In June of 2024 Stephen Tilly, Architect (STA) was engaged by the Washington's Headquarters Homeowner's Association, represented by Ken Colao (KC), Board Member, and Belinda Watts (BW), Principal of Row Partners (Owner's Rep), to perform probes at the Washington's Headquarters at 152 Broadway in Dobbs Ferry, NY. The probe locations were determined in discussions between Andreas Hubener (AH) of STA, BW, KC, and Dariusz Mikucki of NY Hill.

**PROBE LOCATION #PL1: (Bldg. 3) Unit 7 Front – Probe Locations**

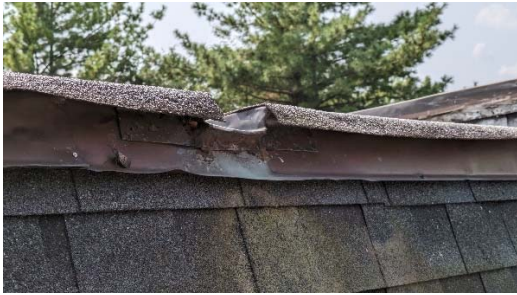
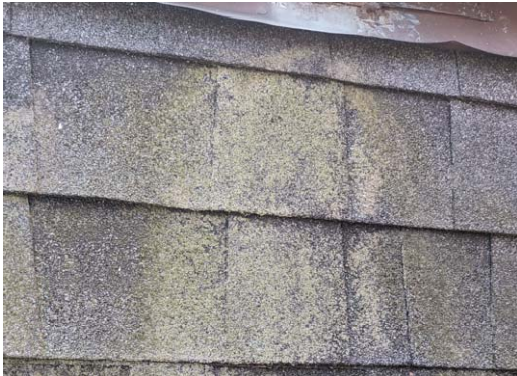
**PROBE LOCATION #PL1: (Bldg. 3) Unit 7 Front – Roof / Mansard**

Conditions: -Incorrect top flashing (between flat roofing and shingles on mansard façade) in poor condition (IMG. 7-110)  
-Missing scupper and leader  
-Shingles in poor condition (IMG. 7-112).

Solutions: -Install new gravel-stop type of flashing, tie it to flat roof. Consider all new roofing membrane on flat roof (IMG. 5-120 shows correct installation on Unit 5).  
-New shingles on mansard façade front and back  
-Reinstall scupper/leader to match other units. Dbl. elbow at bottom of leader (IMG. 8-130 shows correct installation at Unit 8).

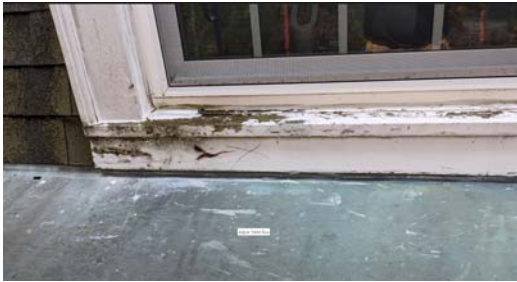
**PROBE LOCATION #PL1: (Bldg. 3) Unit 7 Front (Cont.) – Dormers / Cornice**

Conditions: -Deteriorated top panels at both dormers (not shown)  
-deteriorated wood sill and apron (IMG. 7-610)  
-Hole on top of cornice flashing (IMG. 7-612)  
-Deteriorated wood underside of cornice (IMG. 7-650).  
Abandoned bird's nest inside cornice (IMG. 7-660).

Solutions: -Repair top panel and drip edge as per detail A at end of report.  
-Repair or replace side panels, sills, aprons, and related side panels and trim as required at both dormers. Dormer framing and base plywood are not impacted  
-Repair end of floor joists, rim joist, and cornice cover boards & trim as required.  
Removal of the entire cornice is NOT required.  
-Solder hole on top of cornice flashing.

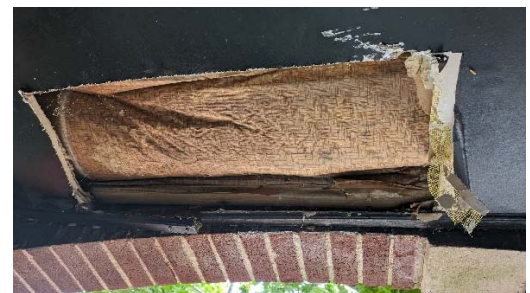
IMG. 7-920

Conditions: -Deteriorated paneling at entrance soffit caused by water infiltration (IMG. 7-910).  
-Soffit framing appears not to be impacted.

Solutions: -Further investigate cause of water infiltration.  
-Replace insulation.  
-Repair and seal soffit.

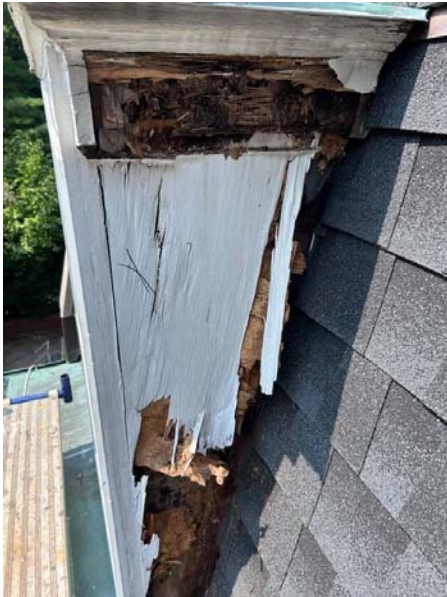
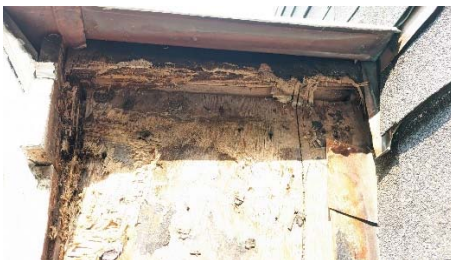
**PROBE LOCATION #PL2: (Bldg. 3) Unit 5 Back - Dormer**

- Although shingles on mansard façade appear to be relatively new, they are of poor quality and/or are poorly installed, resulting in several patches of missing shingles (not shown).
- Improper installation of drip edge. Deteriorated top panels at both dormers (IMG. 5-510 after removal). Base plywood is not impacted.
- Deteriorated side panels at both dormers (IMG. 5-554 & 5-555, during and after removal). Base plywood is slightly impacted.
- Correct installation of copper top of barrel (IMG. 5-210). Gap between copper top and wood trim (IMG. 5-250). Comparable details at Bldg. 5 (Unit 15) are constructed differently.

- New mansard roofing only in back.
- Replace top panels and trim (seal gap). Repair includes drip edge as per Detail A at end of report.
- Replace side panels, sills, aprons, and related trim as required at both dormers. No repairs at dormer framing and base plywood required.

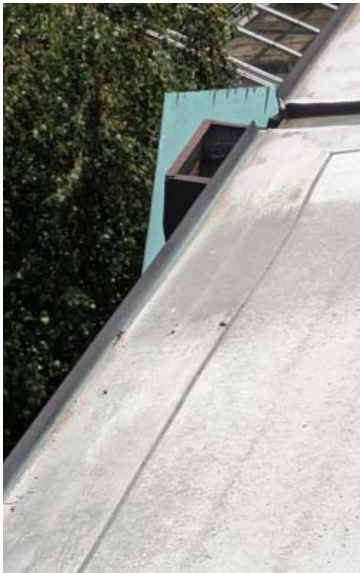
**PROBE LOCATION #PL4: (Bldg. 5) Unit 15 Front – Roof / Mansard / Dormers**

Conditions: -Flat roofing membrane and shingles on mansard façade are past their life span. Seams and connection to flashing have been inadequately repaired with bituminous mastic, which may contain asbestos (IMG. 15f-102 & IMG. 15f-510).

-Incorrect top flashing (between flat roofing and shingles on mansard façade) in poor condition (IMG. 15f-110). Failing caulking to flat roof (IMG. 15f-105)

Solutions: -Install new gravel-stop type of flashing (between flat roofing and shingles on mansard façade), tie it to flat roof. Consider all new roofing membrane on flat roof. IMG. 5-120 shows correct installation on Unit 5

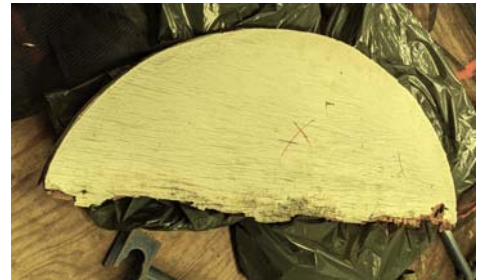
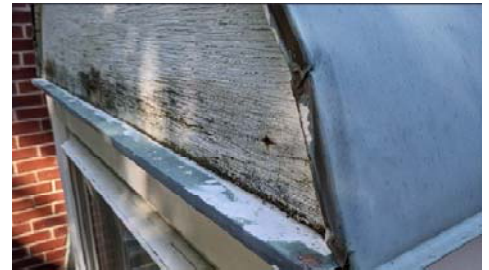
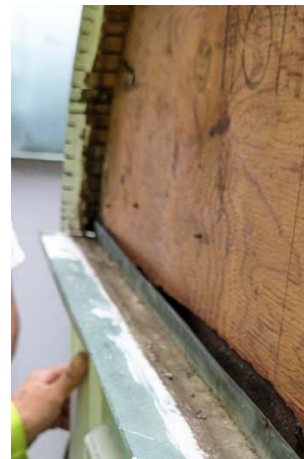
- Improper installation and repairs of cap flashing on knee wall between Units 14 & 15 (IMG. 15b-150).
- Open seam at cornice flashing (IMG. 15b-310).
- Top of copper barrel flashing has been cut during a previous repair attempt. Note soldering to cover nail heads. Improper front edge (IMG. 15b-505).
- Deteriorated side panels (not shown) and top panels (IMG. 15b-515, after removal) at both dormers. Base plywood is not impacted.
- Improper pitch of drip edge. Caulking between top panel & drip edge (IMG. 15b-520 & IMG. 15b-522), resulting in trapped water at transition.
- Steel grates at patio doors (N.I.C.) are in good condition and do NOT need to be painted (IMG.15b-910).

- Replace cap flashing on knee wall between Units 14 & 15 (roof repair). Consider all new roofing membrane on flat roof and knee walls.
- Replace copper top of barrel at right dormer (left dormer t.b.d.) and install properly (as in Bldg. 3, Unit 5, IMG. 5-210).
- Replace top panels and trim (seal only upper gap). Repairs including drip edge as per Detail A at end of report.
- Replace side panels, sills, aprons, and related trim as required at both dormers. No repairs at dormer framing and base plywood required.

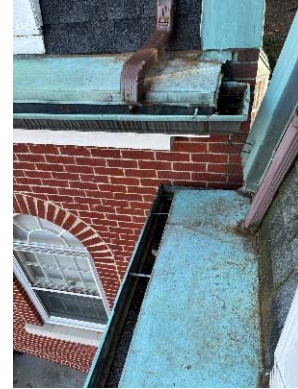
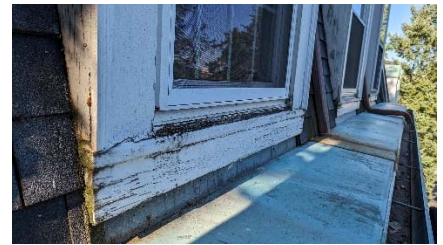
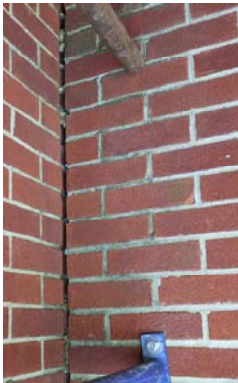
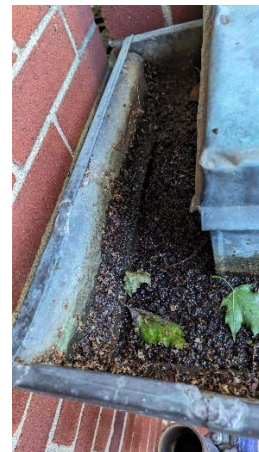
- Biological growth on brick in corner between Units 18 & 19 (IMG. 9-010)
- Transition between units not sealed (IMG. 9-710)
- Roof shingles in poor condition (not shown)
- Deteriorated wood sill and apron (IMG. 9-305)
- Clogged leader. Leader extends too close to cornice (IMG. 9-310).
- Return of gutter is back pitched, causing clogging, spilling and biological growth (IMG. 9-312).
- More spilling may be contributed by the gutter of Unit 18 (IMG. 9-302)
- Arched windows in need of putty repairs and painting (IMG. 9-810).

- Clean biological growth.
- Insert backer rod and caulk transition between units.
- Replace top panels, sills, aprons, and related side panels and trim as required at all dormers. Dormer framing and base plywood are not impacted.
- Replace shingles on mansard façades in front and back.
- Shorten 3 of 4 leader and install dbl. elbows at bottom of leader. IMG. 9-305 shows that dbl. elbows are installed at one leader. Consider replacing and properly attaching all (4) leaders during façade shingle replacement.
- Pitch / repair as required / re-attach gutters at both Units 18 & 19.
- Re-putty and paint (3) arched windows (N.I.C.). This requires the removal and possibly replacement of triple-track storm windows.

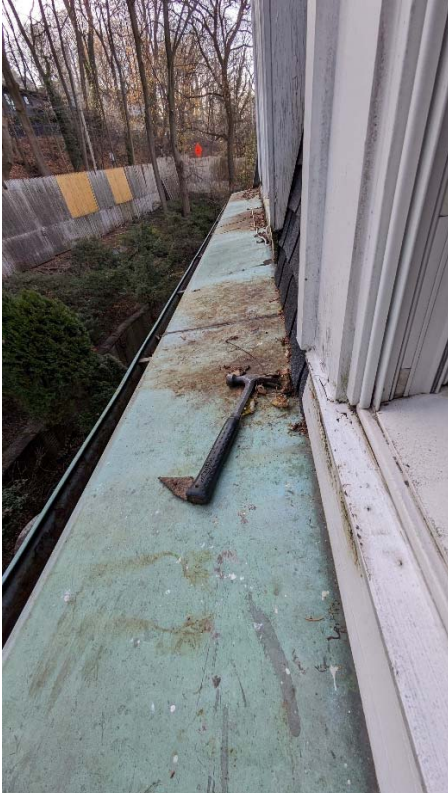
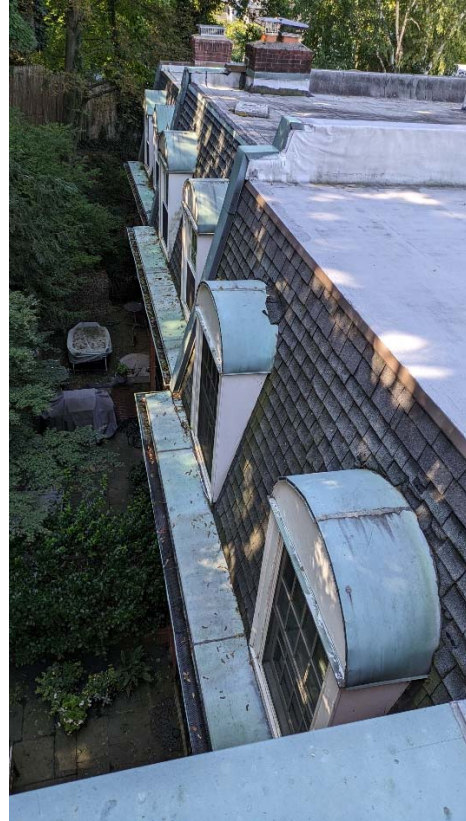
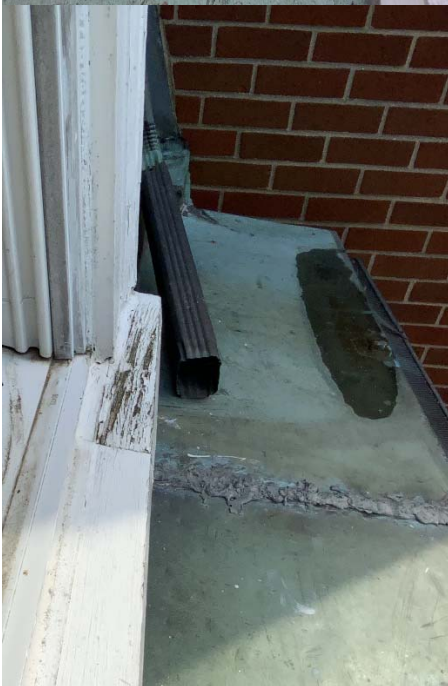
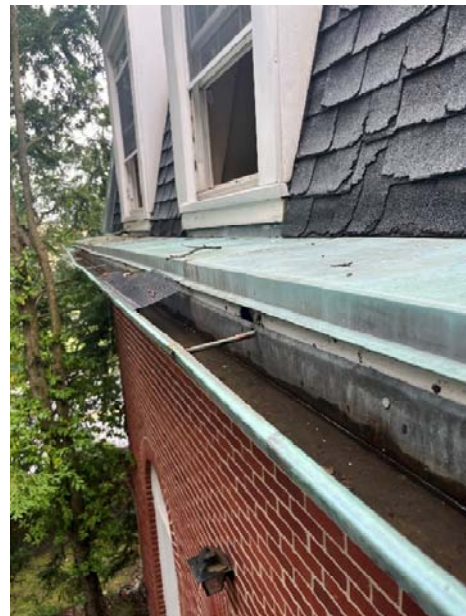
IMG. 14-310 Badly Maintained Cornice Flashing Unit 14 Back  
IMG. 11-310 Poorly Repaired & Dented (Puddling) Cornice Flashing;  
Incorrect Leader Installation Unit 11 Front

IMG. 16-210 Expired Roof Membrane & Mansard Shingles;  
Improper Flashing/Dormer Top Repairs Units 16/17/18  
IMG. 21-310 Gutter Detached/Damaged/Clogged Unit 21

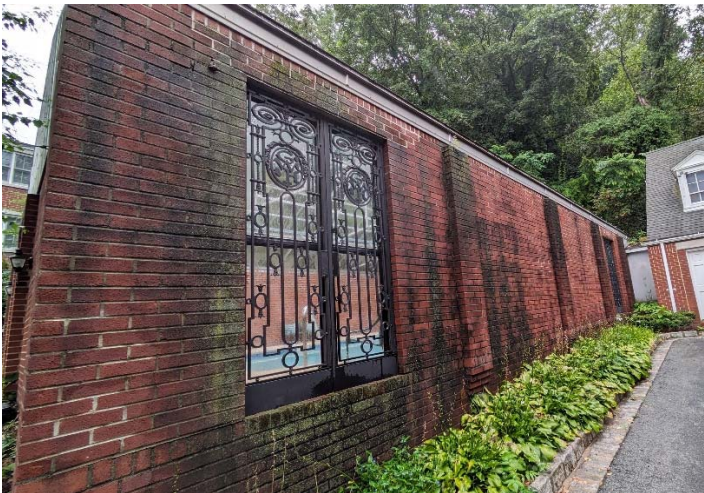
IMG. P-900 Flooded Pool

IMG. P-710 Biological Growth & Wash-Out Mortar South Elevation
